# Battle against the Kamikaze

The moment a kamikaze struck USS Suwannee on 26 October 1944, the second strike on the ship in two days

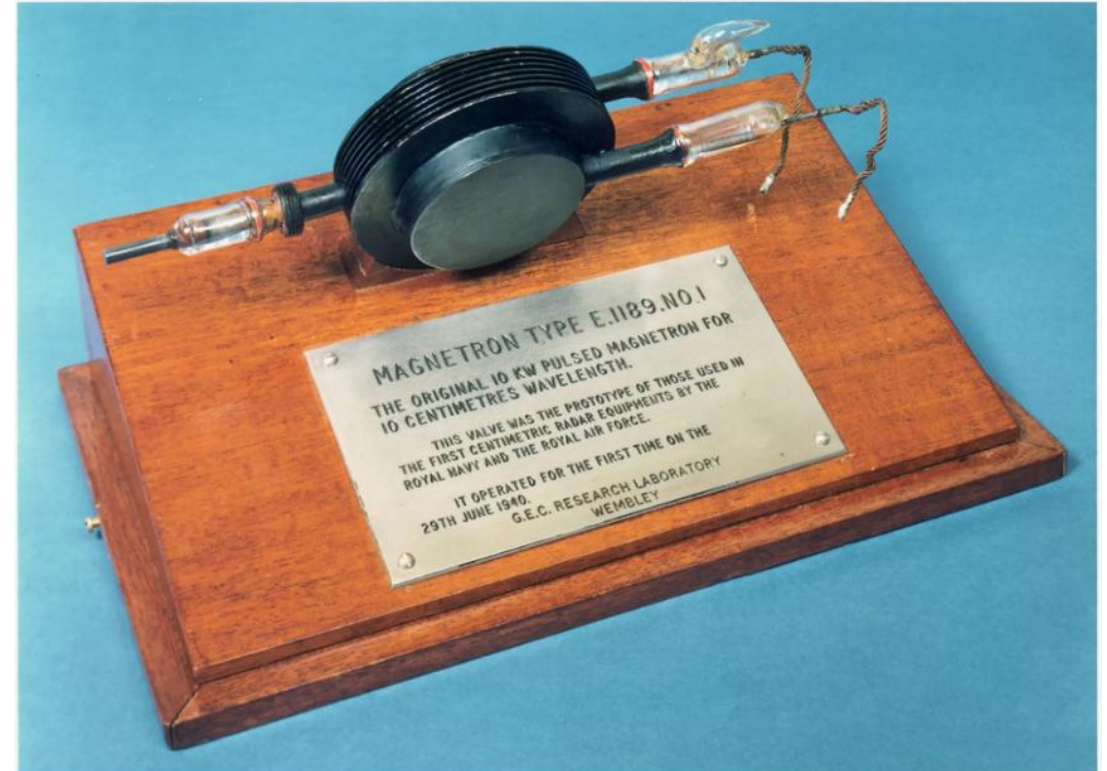
GEC E-1189 Magnetron No.1 (No. 12 was taken to America on the Tizard Mission).

- An early 10 kW version, built in England was taken on the Tizard Mission to America in September 1940.
- As the discussion turned to radar, the US Navy representatives began to detail the problems with their short-wavelength systems, complaining that their klystrons could only produce 10 W. With a flourish, "Taffy" Bowen pulled out a magnetron and explained it produced 1000 times that.
- Bell Telephone Laboratories took the example and quickly began manufacturing copies, the first thirty in October 1940.
- Before the end of 1940, the Radiation Laboratory had been set up on the campus of MIT to develop various types of radar using the magnetron.

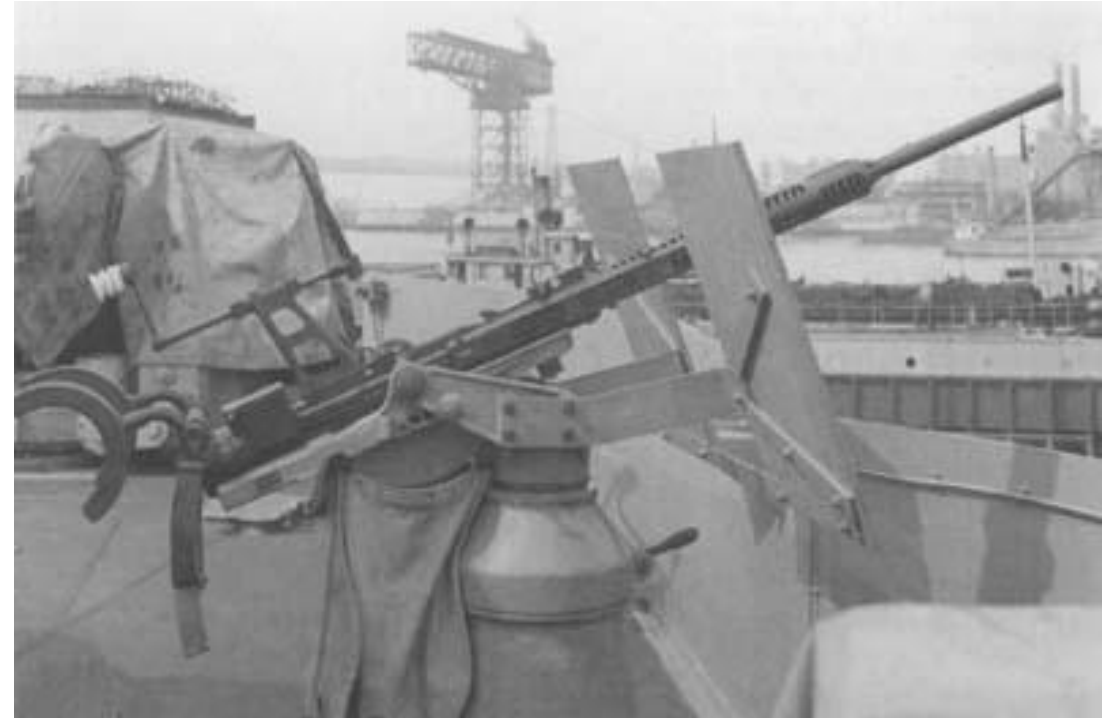
Close-up of a 20mm anti-aircraft mount.

- The relative disadvantages of the 20mm were its short range and limited destructive power of its small explosive shell.
- The question was, How do you get hits?

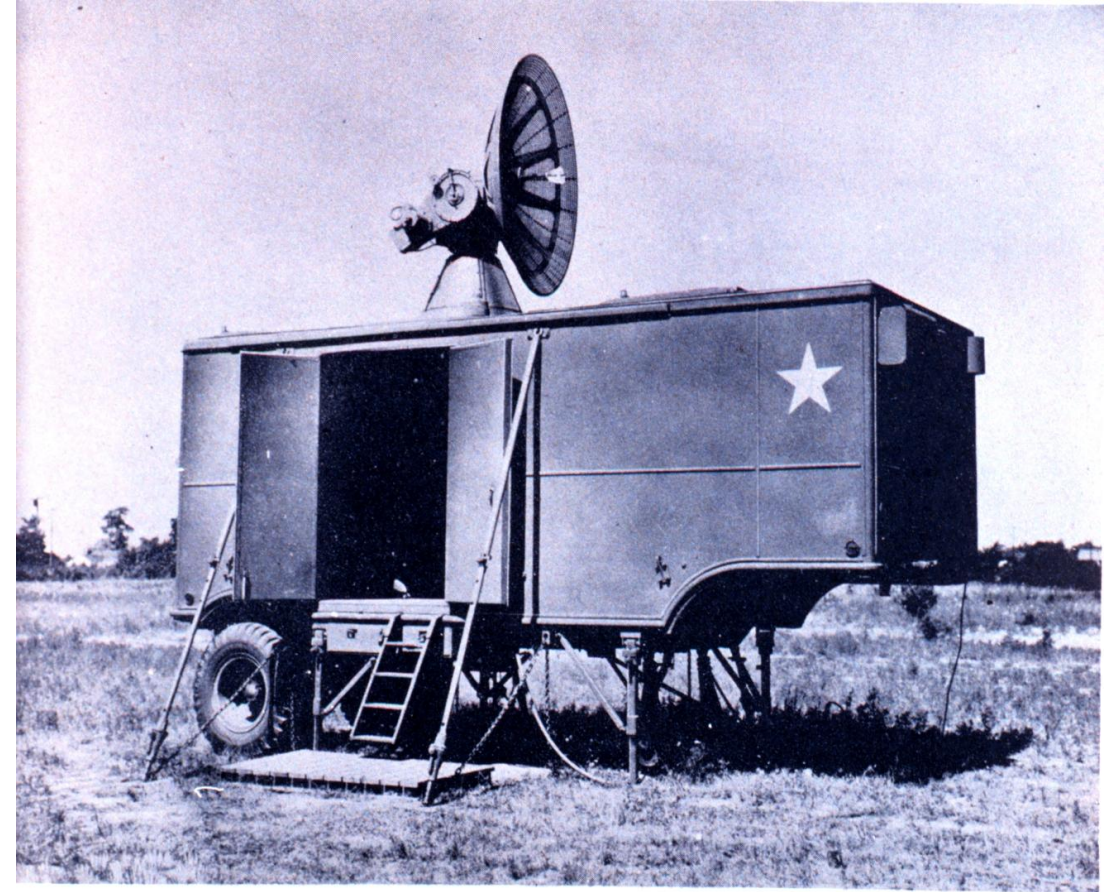
Figure 22. Exterior View of Radio Set SCR-584.

- When tested at Fort Monroe in February 1942, the prototype aircraft tracking radar located objects within six-hundredths of a degree and twenty yards in range.
- The Army ordered over 1,200 units, designating the radar SCR-584.
- Connected to the Bell Labs M-9 predictor, which calculated where targets would be when shells arrived, the system transformed anti-aircraft gunnery.

- The SCR-584's most dramatic success came against the V-1 flying bomb. Beginning in June 1944, Germany launched thousands of pilotless weapons against London.
- The SCR-584, combined with the proximity fuze achieved extraordinary results
- These electronic aids arrived in quantity from June 1944.
- Before this combination entered service, anti-aircraft guns destroyed fewer than one V-1 in four; afterward, they destroyed approximately 85 percent of targets engaged.

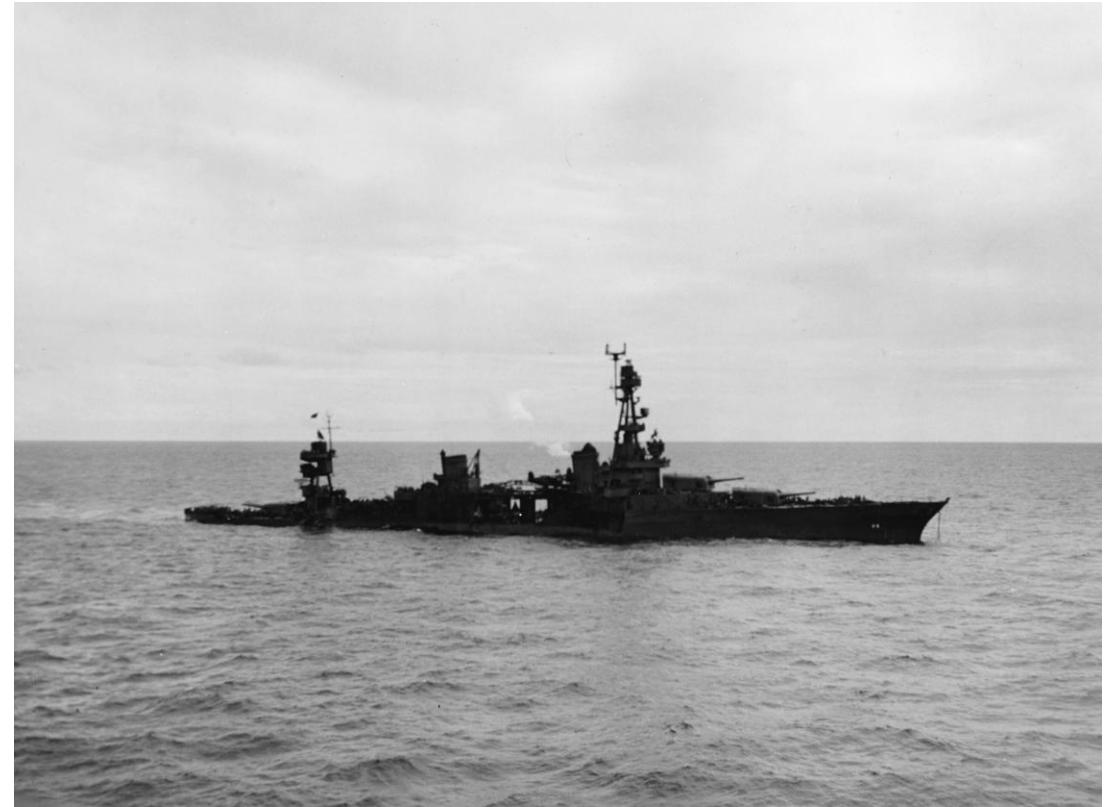
USS Chicago low in the water on the morning of 30 January 1943, from torpedo damage inflicted the night before

- Louisville took Chicago under tow, transferred the tow to the ocean going tug Navajo the next day.
- Even though she was under strong air cover, Japanese torpedo planes again attacked Chicago without being detected, and in spite of heavy Japanese aircraft losses, hit her with four torpedoes, sending the cruiser under.

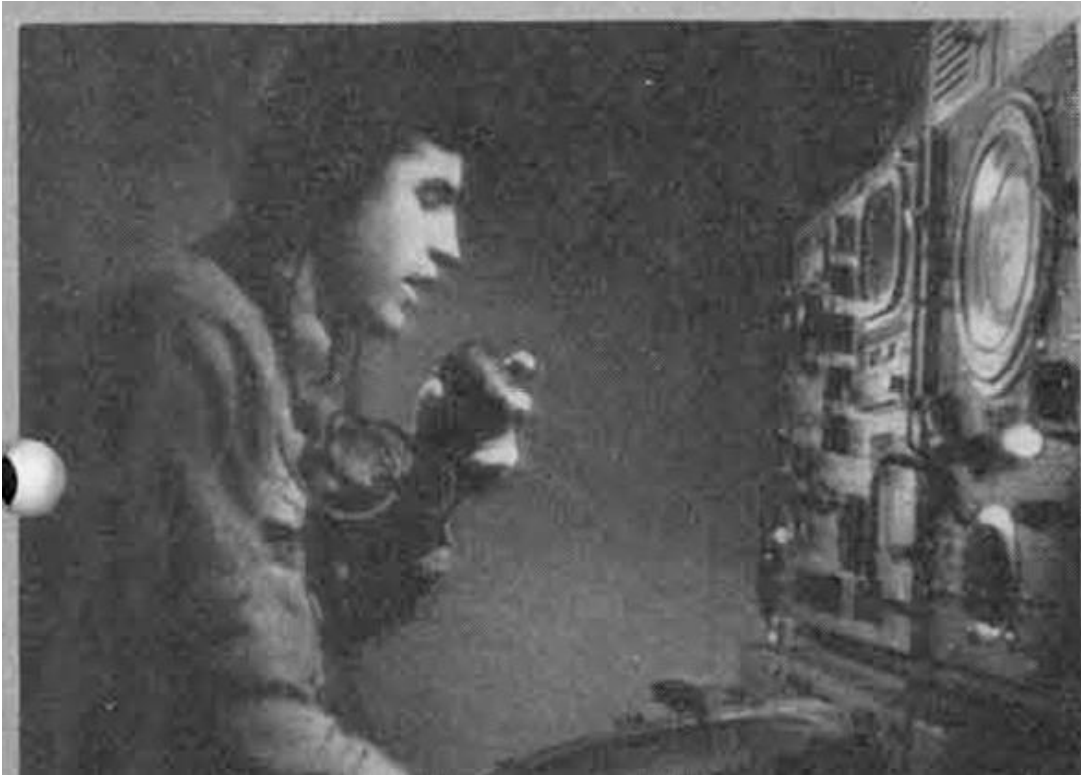
◀ Unidentified aircraft—*bogeys*—are detected by the long range search radar. The operator reports to the Combat Information Center, giving the bearing and range of the aircraft.

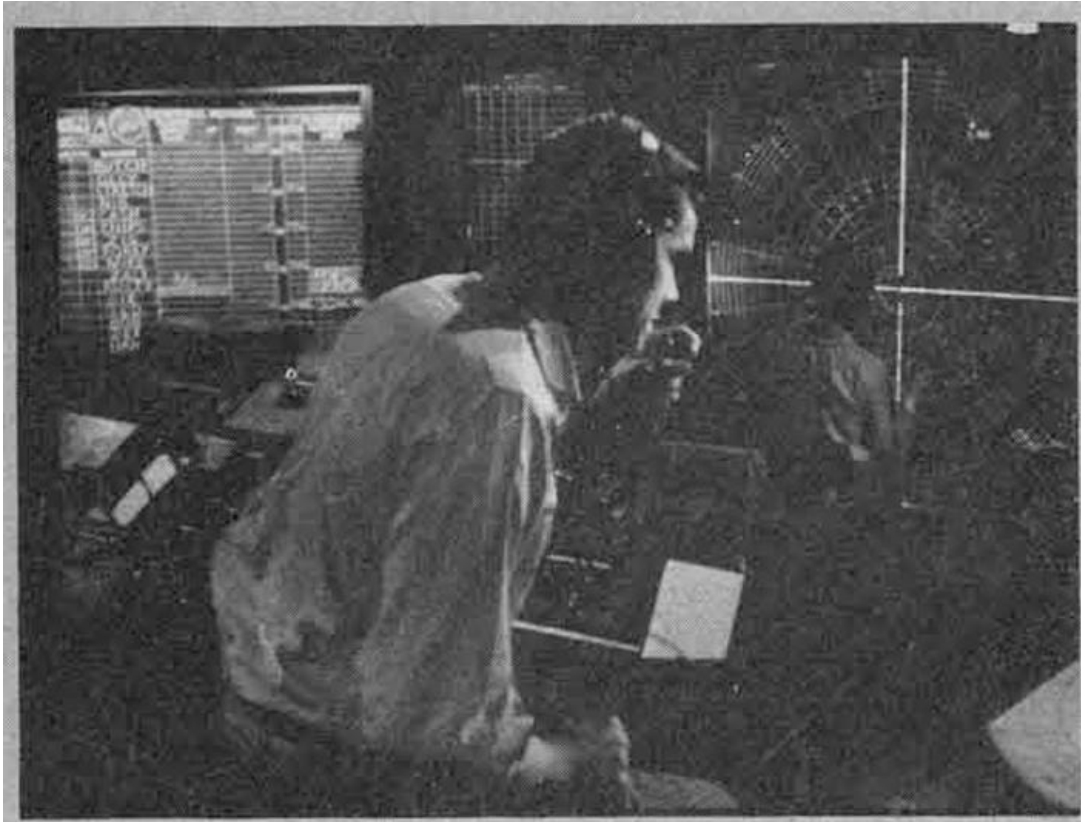
◀ The force fighter director designates the raid by number, gives instructions for the interception of the raid, and informs the task force commander of the action taken.

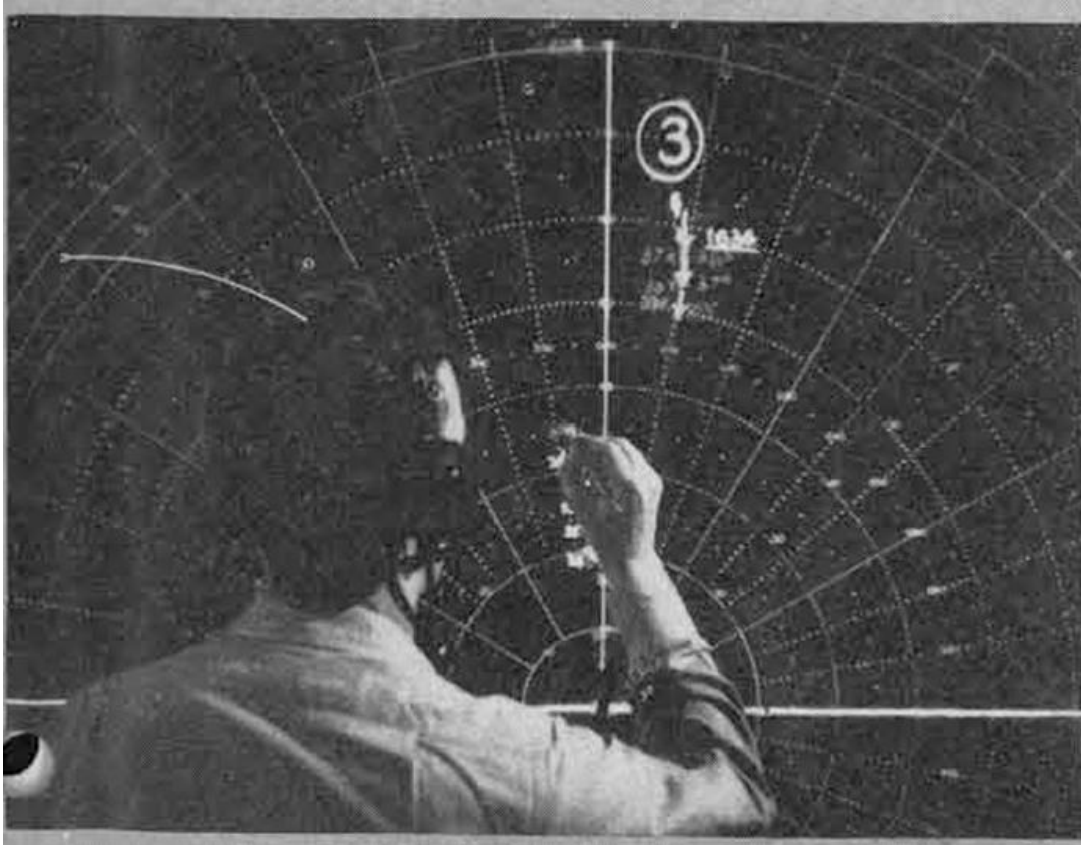
◀ The officer in front of the vertical plot evaluates the radar plots visible to him through the board and marks the estimated position of the planes for a particular time. He is shown here marking the position of *friendlies* on their way out to intercept raid 3.

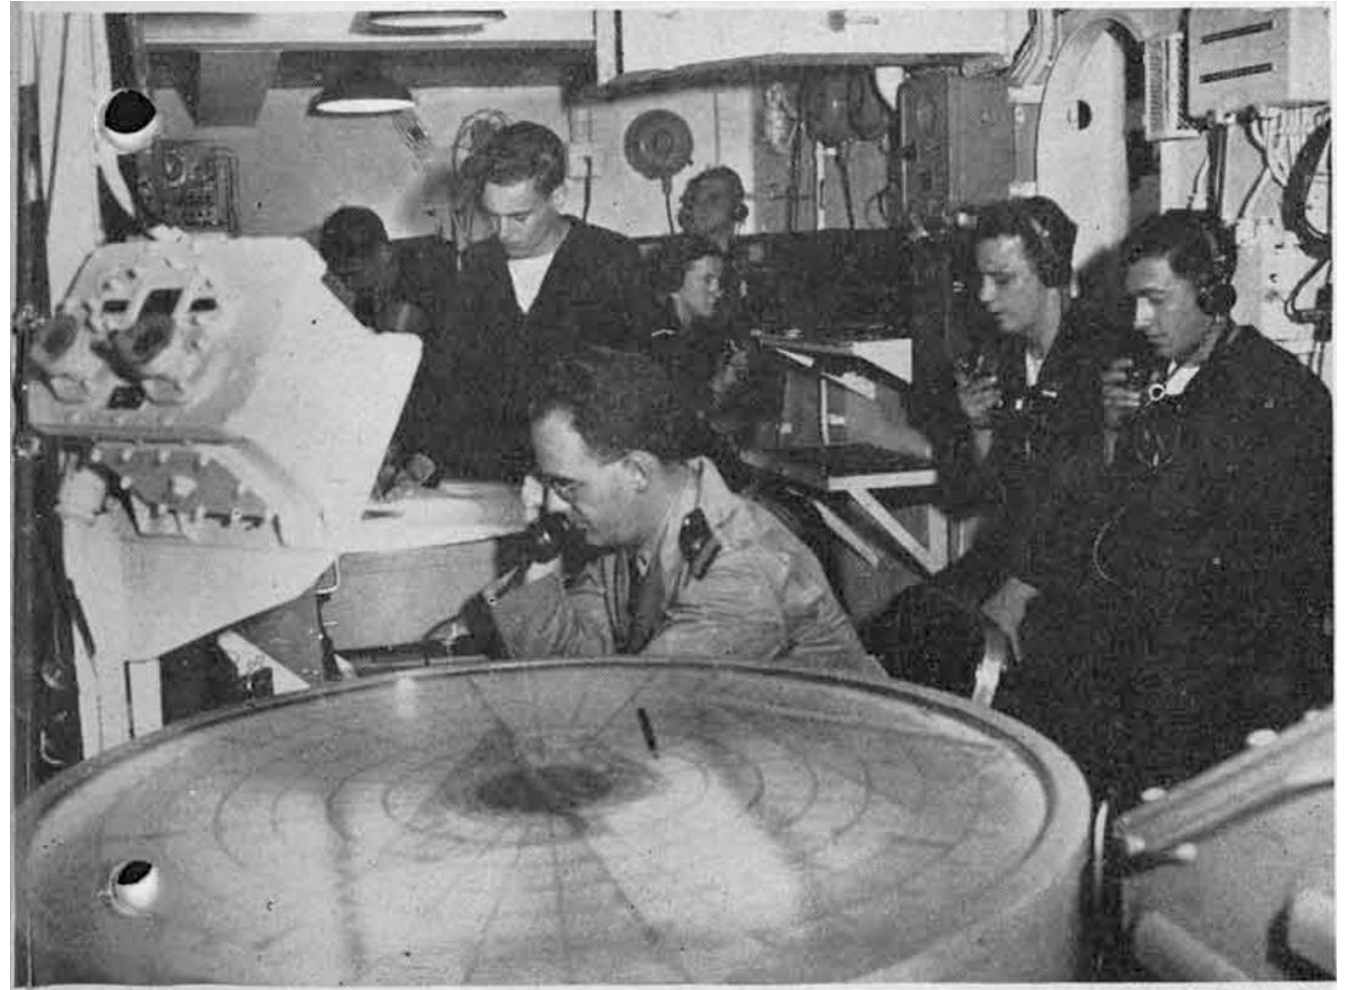
*CA, with battle stations manned. Looming up in the left foreground, in front of the CIC watch officer, is a TDT (target designation transmitter) giving ranges and bearings to remote stations. Often, on Cruisers, the TDT is located beside the radars but here, interestingly, is stationed beside plot.*

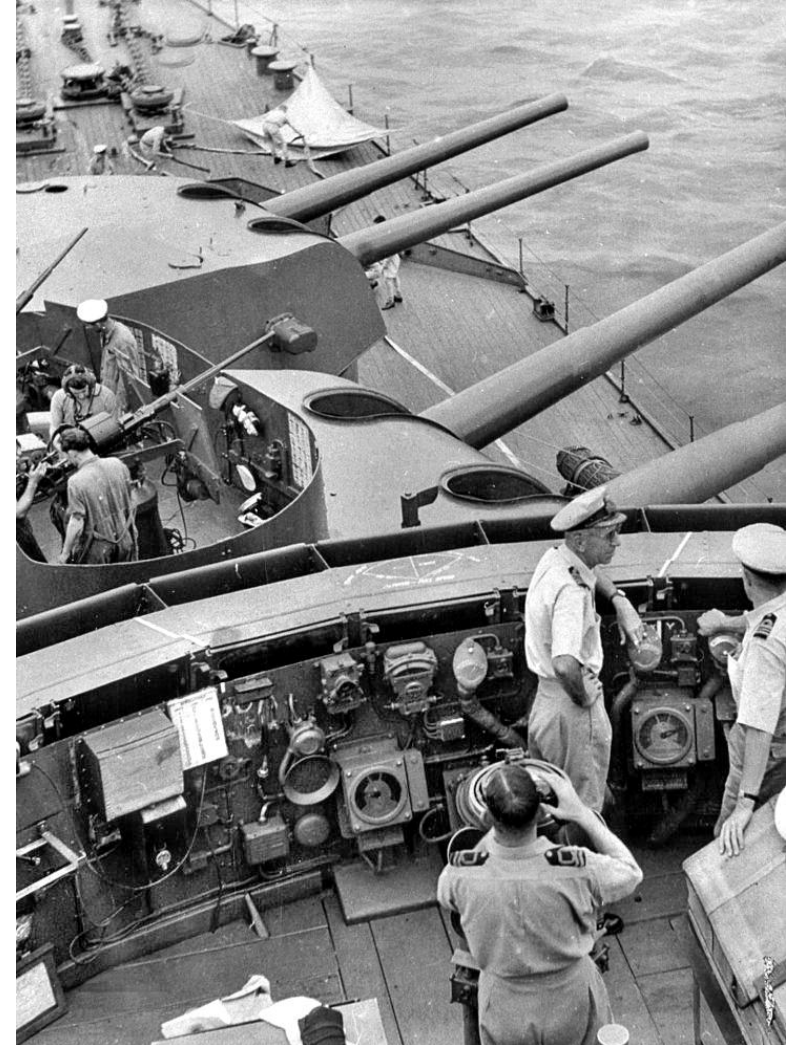
- Captain Nichols in Shropshire reported damage in Australia:
- There was a large explosion and an intense fire was started in the Air Defence position and bridge.

- Type 273 Radar Hut and lantern fell on to the compass platform, both H.A. Directors and D.C.T. were put out of action, and the port strut of the foremast was broken.

- Photo: The bridge and forward superstructure of Australia in September 1944. This area was damaged when a Japanese bomber collided with the ship on 21 October 1944. Captain Emile Dechaineux (white uniform, facing right), was among those killed

- The fire was brought under control very quickly and by 0635 the large quantity of wreckage on the compass platform and A.D.P. had been cleared away.
- Commodore J. A. Collins suffered burns and wounds; Captain E. F. V. Dechaineux and Commander J. F. Rayment were mortally wounded.

- Thirty officers and men were killed or died of wounds and 64 officers and men were wounded, 26 seriously.
- Australia retired to Manus and then to Espiritu Santo where she was repaired and was ready to sail to rejoin by 28 November.

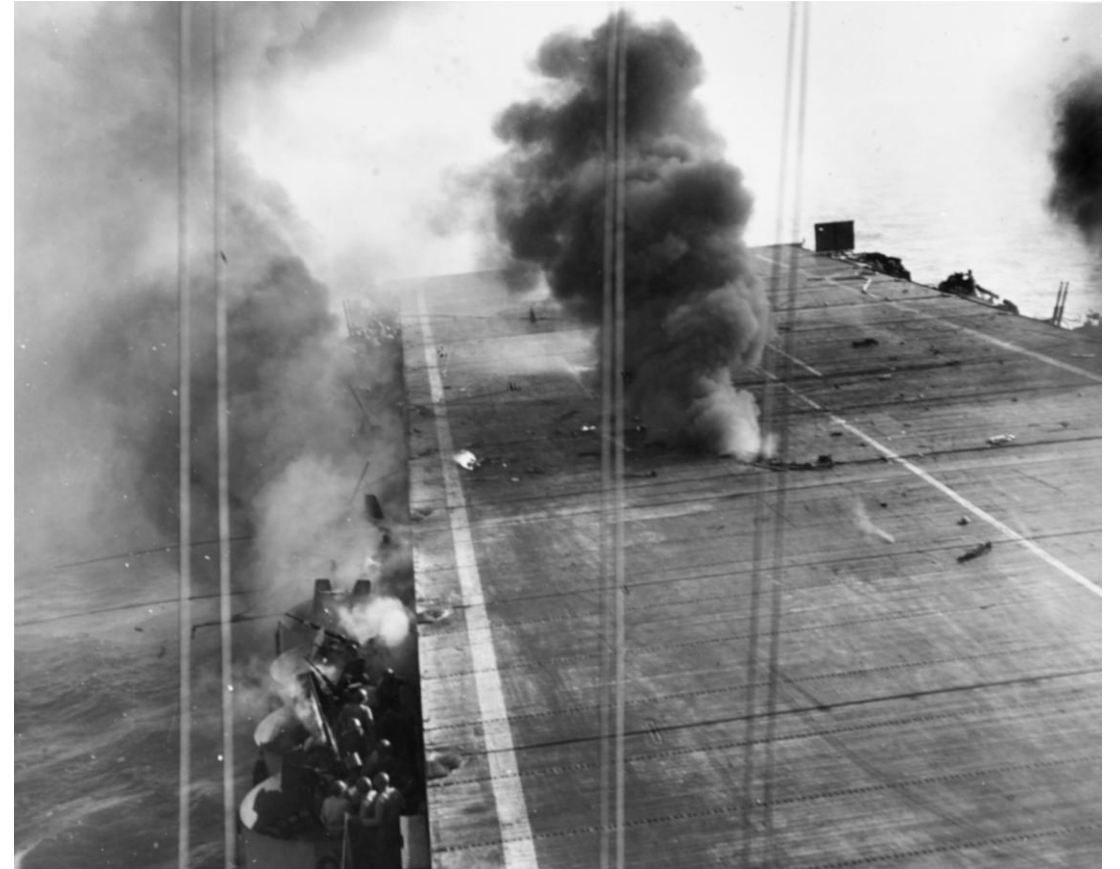
- At 0800 another bombed up Zero made a hit in the middle of the light carrier Suwanee's flight deck, causing severe personnel casualties.

View of the attack of a Japanese A6M5 kamikaze suicide plane aboard the U.S. Navy escort carrier USS Suwannee (CVE-27) off the Philippines on 25 October 1944: the kamikaze's 250 kilogram bomb has just exploded between flight and hangar decks and fire billows out.

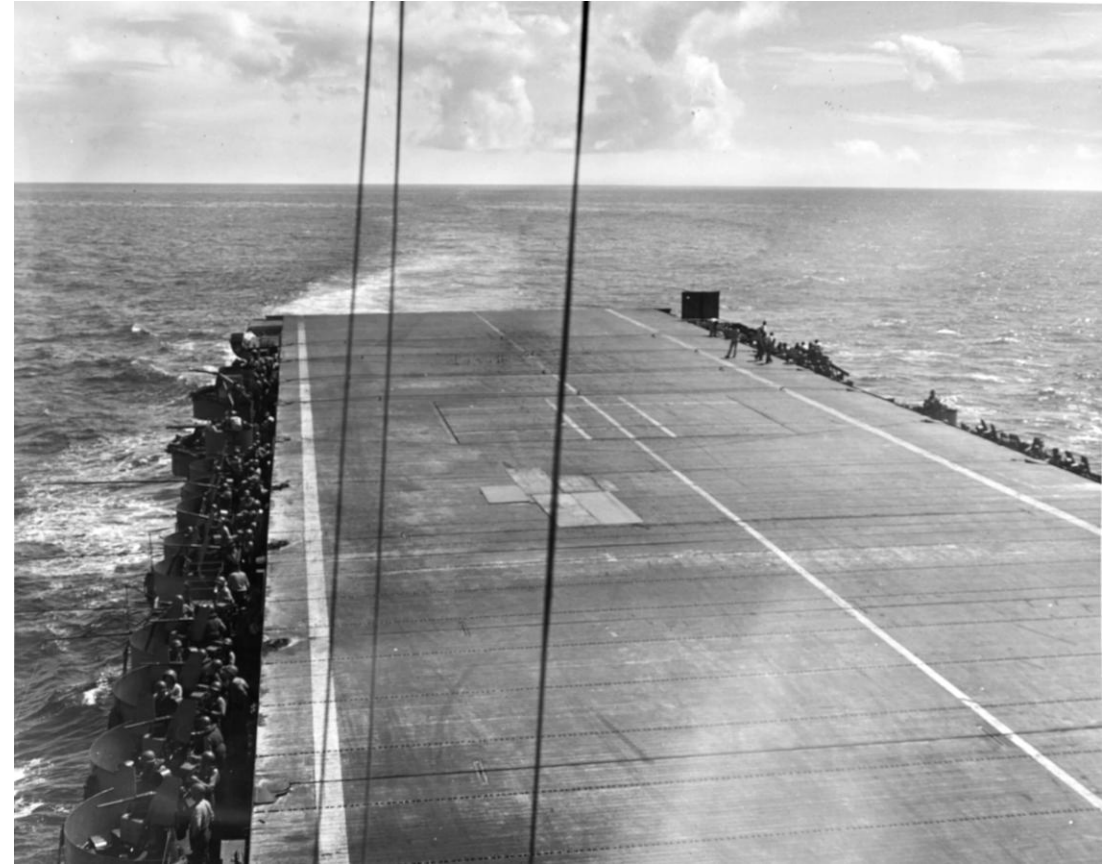
- However, the flight deck was repaired in two hours.

View of the flight deck of the U.S. Navy escort carrier USS Suwannee (CVE-27), 90 minutes after a Japanese suicide plane's bomb had ripped a hole in it. The hole is patched and the ship is ready to land aircraft. Note that only four wires, instead of eight, are being used. All landings were made without mishap.

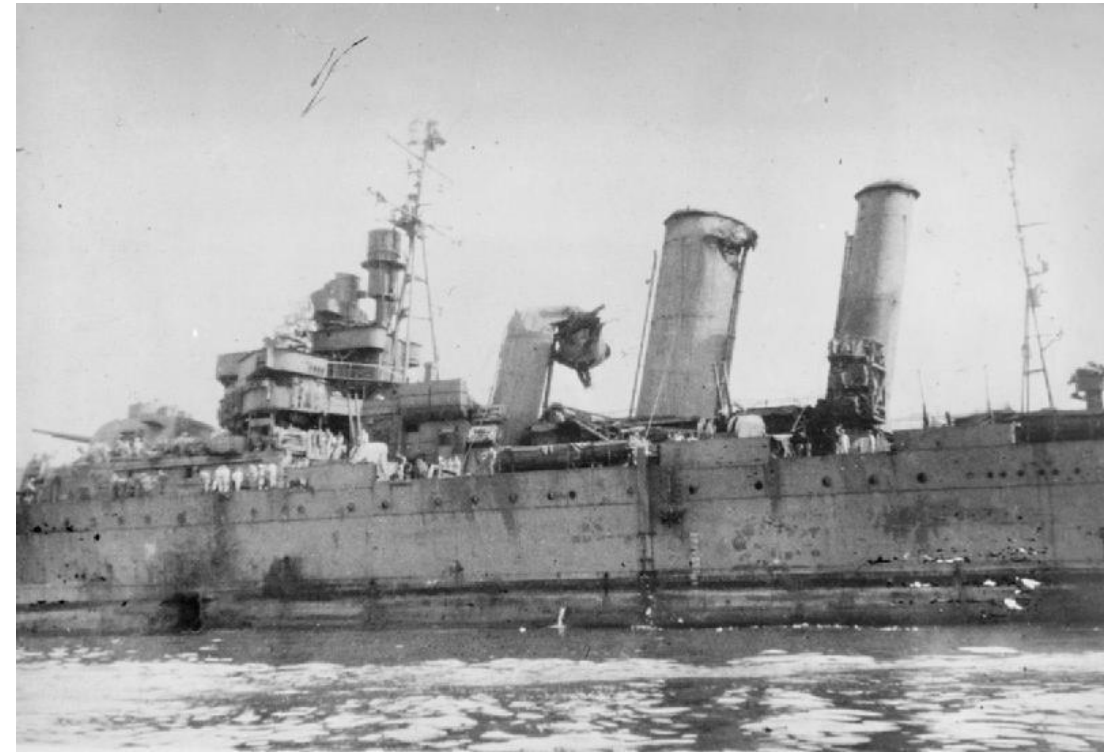
- Australia had completed her scheduled bombardments by 10.30 a.m. and, since no targets of opportunity arose had not again fired.
- At 1.11 p.m. two aircraft were sighted coming in from the east.
- One dived past Australia and hit U.S.S. Mississippi near the bridge.
- The other came in ahead of Australia after a curving dive and tried to hit the cruiser's bridge and fore controls.
- He missed his aim, however, and diving under the foreyard his wing tip caught on a mast strut which swung him into the foremost funnel and over the side.
- There was no other material damage than cutting off the top third of the funnel, which necessitated closing down two boilers in "A" boiler room, and damage to radar and WT aerials, which was quickly repaired.
- There were no casualties.
- A hole was cut in the damaged funnel by next day and all boilers were again in action

Australia in January 1945 showing accumulated damage from kamikaze attacks

- Despite her damage, Australia met her scheduled bombardment engagements, though the blast effect of firing her forward 8-inch guns on the port side was straining the inner bulkheads, so that it was decided not to fire them on that side except in an emergency.

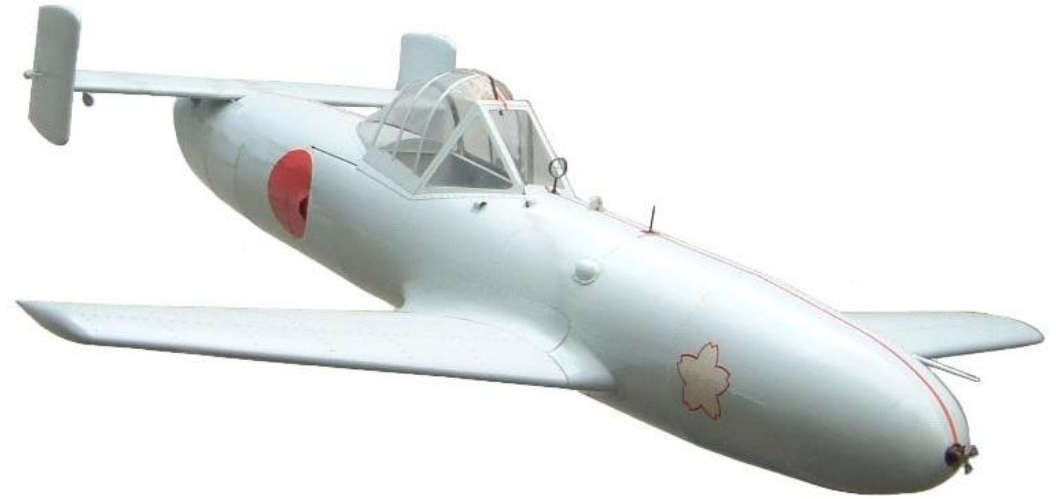
A replica of the Yokosuka MXY7 Ohka Model 11. Ōka; "cherry blossom"; is a purpose-built, rocket-powered human-guided kamikaze attack aircraft. The only variant to see combat, was the Model 11; armed with a 1,200-kilogram warhead and powered by three Type 4 Model 1 Mark 20 solid-fuel rocket motors. Starting on 21 March 1945, the Ohka flew combat missions. Although extremely fast, the Ohka had a very short range of 37 km and had to be carried into action by a much larger bomber that frequently proved to be vulnerable to carrier-borne fighters.

- Intercept was fifty miles out from the main body, and all eighteen bombers were shot down at a cost of two USN fighters.
- Thus, it was found that the best defense against the cherry blossom was destruction of their mother planes before they got to launch point.
